# E2ReBuild

Industrial Energy Efficient  
Retrofitting of Resident  
Buildings in Cold Climates

## D2.3 Demonstrator Voiron

<b>Project no:</b>	260058	<b>Project acronym:</b>	E2ReBuild
<b>Due date:</b>	2014-06-30	<b>Submission date:</b>	2014-06-24
<b>Dissemination:</b>	Public		
<b>Partners:</b>	<u>OPAC38</u>		
<b>Authors:</b>	<u>Benoît JEHL</u>

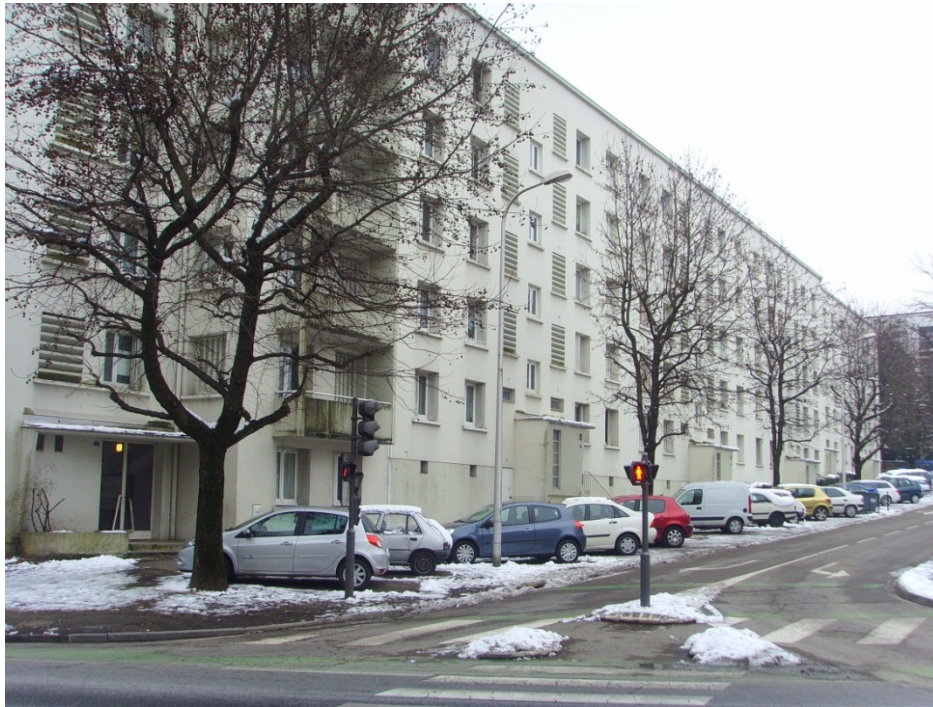
The building is made of concrete with no insulation. It's a typical construction from the 60's and 70's [Figure 2]. There were only minor works carried out before the deep retrofitting within E2ReBuild: recently (in 2000) the initial single glazed windows have been changed for PVC-framed double-glazing 4-10-4. Thus, thermal properties are rather poor:

- Wall: no insulation (20 cm concrete + 5 cm air + 5cm brick),  $U=1.75 \text{ W/m}^2\cdot\text{K}$ ;
- Roof: poor insulation (20 cm concrete + 4 cm cork),  $U=1.05$ ;
- Floor: no insulation (8 cm concrete + 15 cm brick),  $U=1.28$ ;

Figure 2: North façade before retrofitting

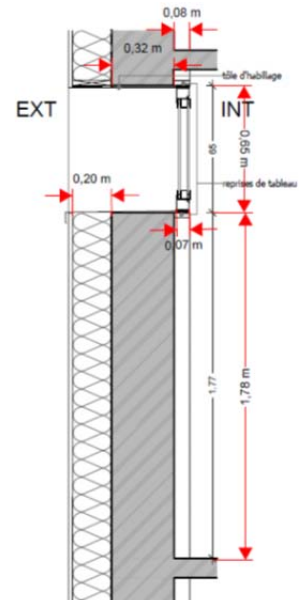
It has to be noted that the windows were kept, although their actual position (on the inner part of the concrete wall) leads to thermal bridges [Figure 4]. Concerns were also raised about mould growth and moisture.

Figure 4: Wall detail

Windows were thus kept. When replacement will be needed, they will be placed at the outer part of the concrete wall, partly covered with the insulation.

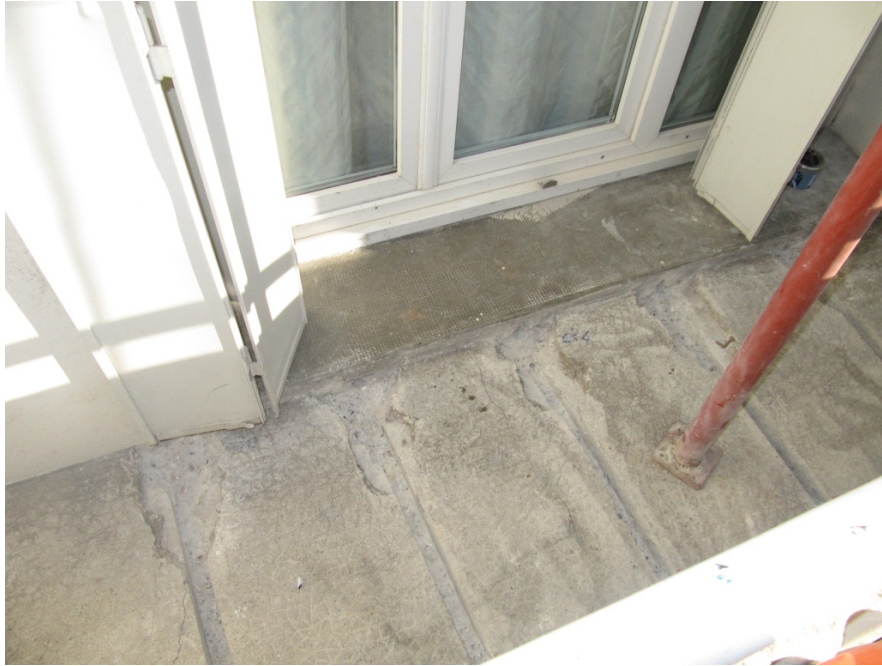
Unfortunately, after in deeper investigation, the balconies were proved not having enough load bearing capacity to support the additional weight of the metallic frame not correctly placed at the construction of the building.

Figure 6: Grooves with injected resin

To continue the work, OPAC38 had to recruit a company for the reinforcement of the balconies. The adapted solution consists of the injection of a resin into grooves to strengthen the support of the balconies by the façade.

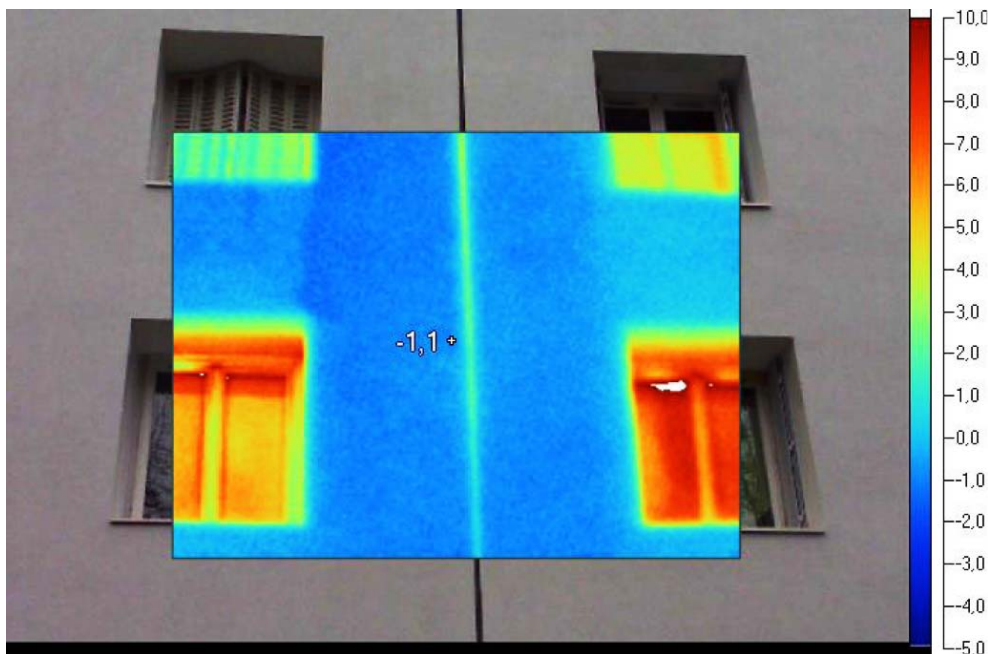
4. Quality of the envelope and thermal bridging. Monitoring confirms the tenants 'view. Thermal images showed no defaults on the insulation, although you can clearly identify the thermal bridges around the windows [Figure 13], and a blowing door test gave an result of  $Q_{4Pa-surf} = 0,630 \text{ m}^3 / \text{h.m}^2$ , much lower than the requested value for new constructions ( $1 \text{ m}^3 / \text{h.m}^2$ ).

Figure 13: Thermal images after work
