E2ReBuild

Industrial Energy Efficient
Retrofitting of Resident
Buildings in Cold Climates

D2.5 Demonstrator Halmstad

Project no:	260058	Project acronym:	E2ReBuild
Due date:	2014-06-30	Submission date:	2014-06-03
Dissemination:	Public		
Partners:	<u>NCC</u> ; Akelius Bostad Väst (ABV)		
Authors:	<u>Stephen Burke</u>		
Revision:	Final

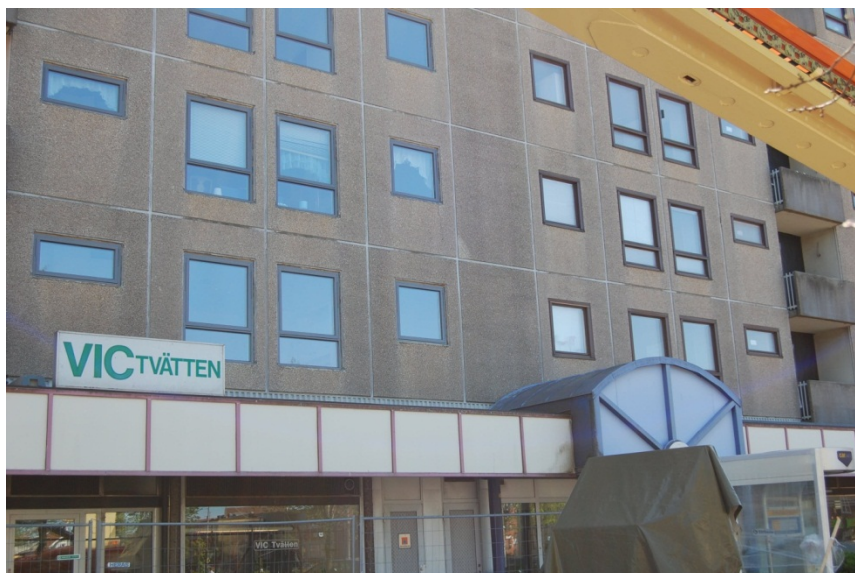
Figure 4: New windows on the left and old windows on the right. The colour was chosen in order to preserve the look of the building (Stephen Burke).

Since the current windows were in a poor state, they were replaced. The new windows were energy efficient windows (overall U-value = $0,9 \text{ W/m}^2\text{K}$) from Elitfönster. It was decided that the look of the building be preserved so windows similar in colour to the old windows were used, see Figure 4, Figure 5, and Figure 6.

The new windows have a low U-value and were properly sealed to reduce the air leakage through the building envelope. These two improvements reduced the heat loss from the apartments in two ways; by reducing the amount of thermal losses through the windows, and by reducing the amount of cold air leaking through the building envelope at an uncontrolled rate. This also helped to reduce the feeling of a cold draft when people are near the windows due to the higher surface temperature of the window and new air diffusers in the air intake. These modifications resulted in an increased thermal comfort level in the apartments and allowed for the reduction of the indoor air temperature from 24°C to 21°C without compromising the thermal comfort of the tenants. These three factors (better U-value, better air tightness and lower indoor temperature) decreased the heating demand by about 35 %.

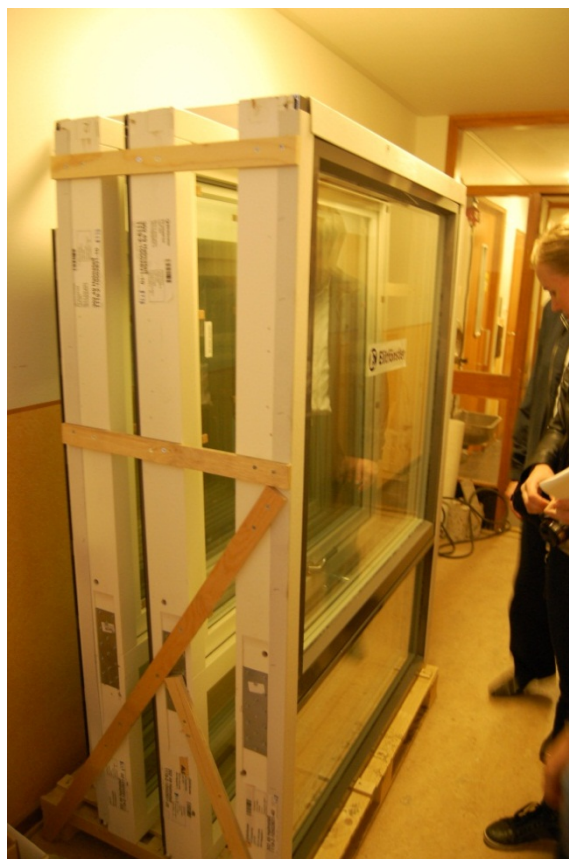
Figure 5: New windows waiting to be installed (Stephen Burke).

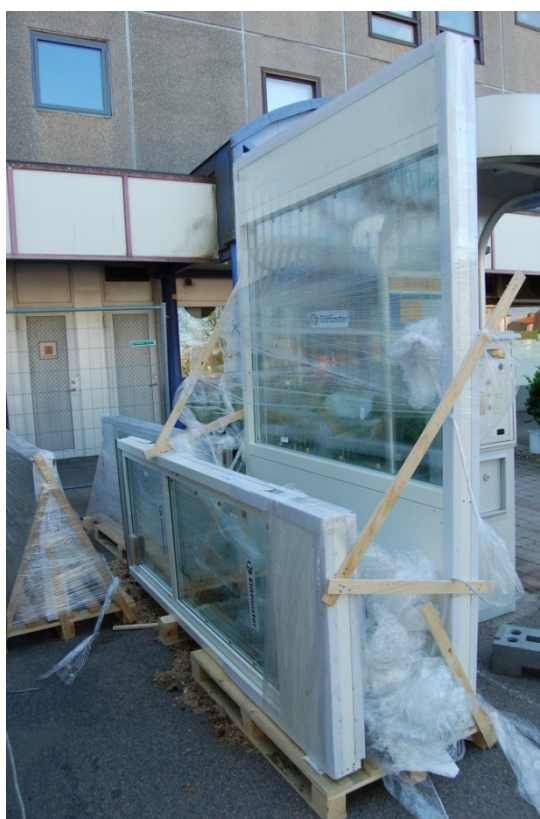
Figure 6: Balcony window and door before installation (Stephen Burke).

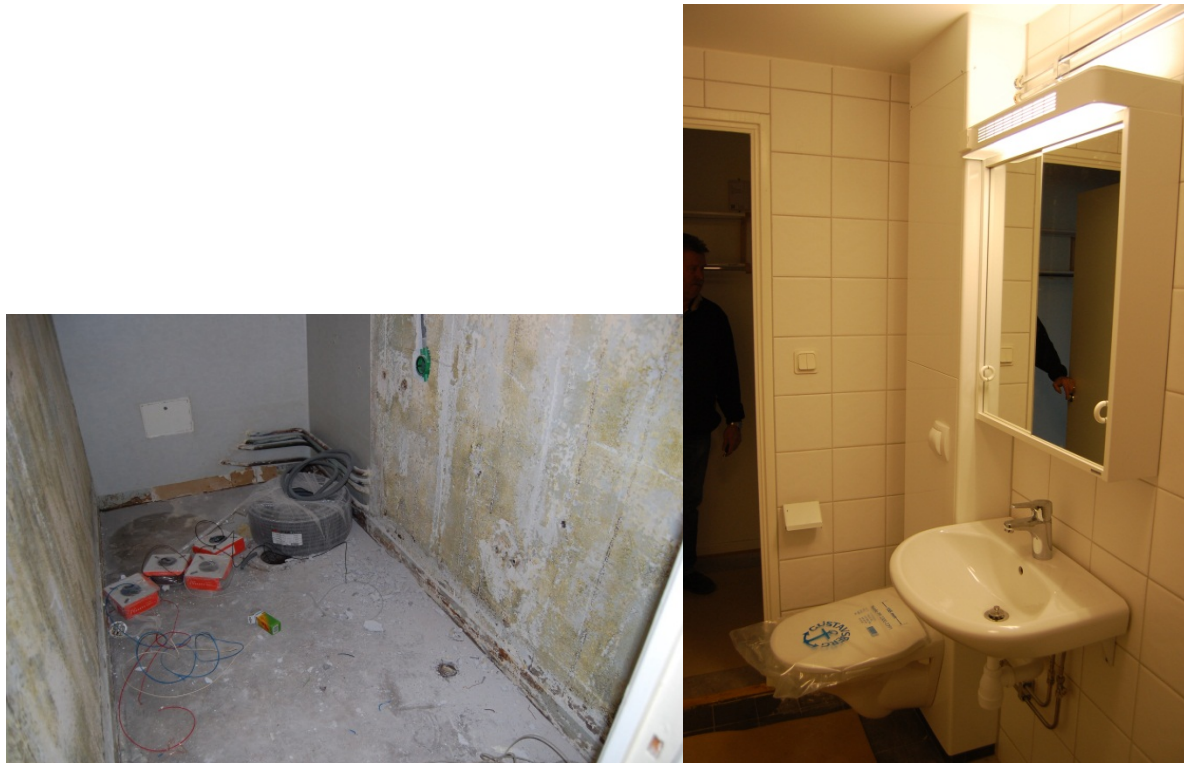
Figure 8: Washroom during (left) and after (right) renovations (Stephen Burke).

It was decided that while these renovations were being done (water and sewer pipes), the kitchen and bathrooms could also be renovated at the same time (Figure 8 and Figure 9). The tenants agreed to this, which meant that the rents could be adjusted according to the legal framework. (In Sweden tenants who can be affected by a renovation must agree 100 % that a renovation project goes ahead otherwise the issue goes to court. In Halmstad 95 % agreed. The case was taken to court and the courts determined there was no valid reason not to renovate.) The renovations of the bathrooms and kitchen did not have much effect on the energy use of the building (reduced domestic hot water use due to low-flow faucets), however they did have a significant impact on the economy of the project resulting in a shorter payback time.

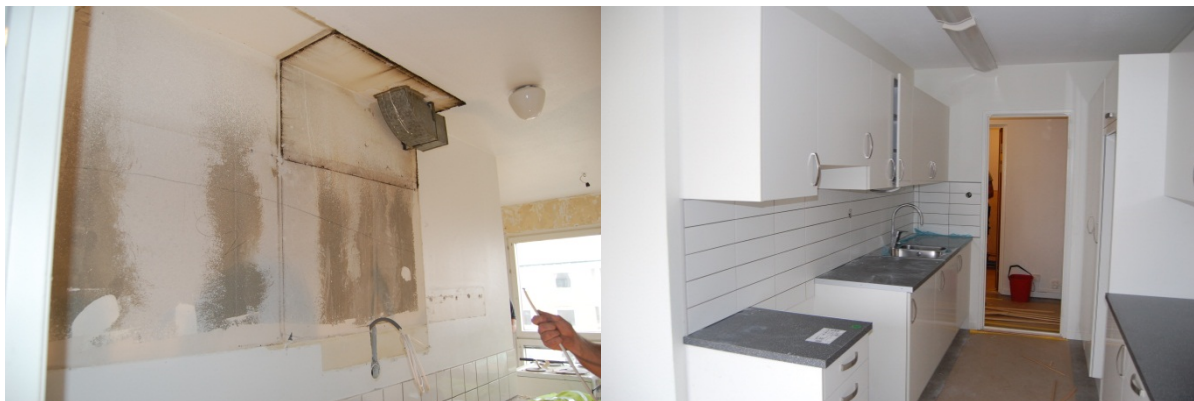
Figure 9: Two kitchens, one during renovations (left) and one after renovations (right) (Stephen Burke).

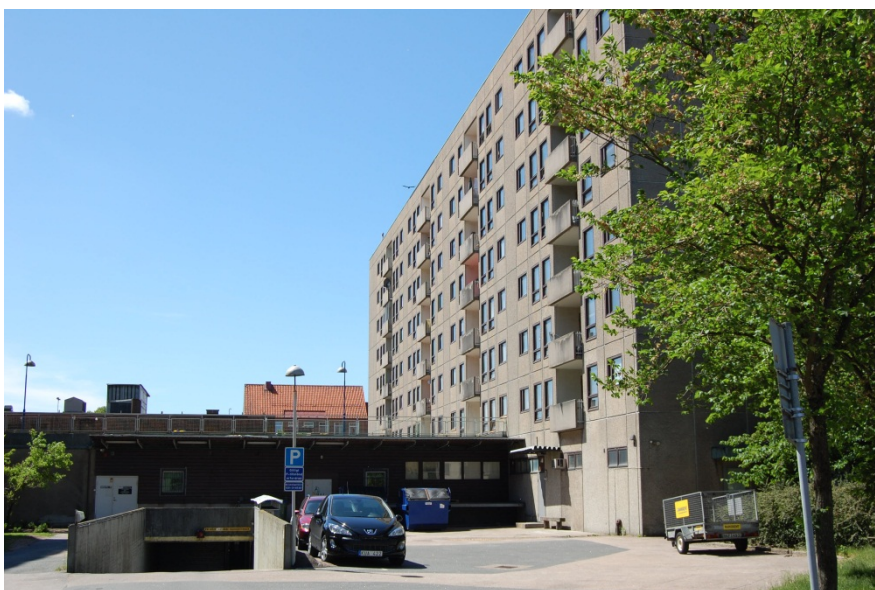
Figure 10: Underground parking garage which was lit up 24 hours a day. Occupancy sensors were installed to reduce the energy use from lighting (Stephen Burke).

The garage lighting was manually controlled. In practice the lighting was on in the garage almost all day and all night. In order to reduce the energy use in the garage, new LED lights with built-in occupancy sensors were installed. These lights have a low-lighting mode so that the lights are constantly on and the lighting strength increases when a person or vehicle moves near each individual light.

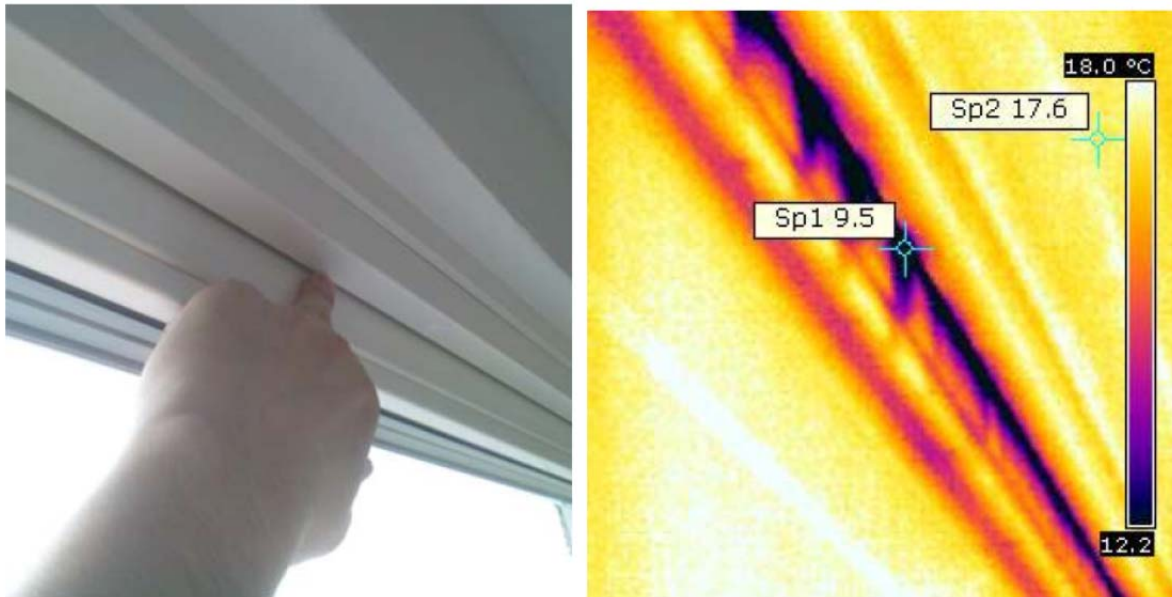
The airtightness was measured and the building was found to be very leaky. Thermography results showed that most of the air leakage was unsurprisingly around the windows and balcony doors (see Figure 13 and Figure 14.)

Figure 13: Air leakage through the rubber seal.

Because of these leaks, the tenants had the heating system on full, resulting in an indoor temperature in the building of around 24-25 °C. Tenants who found this to be too warm opened the windows to cool their apartment. About 6-7 % energy per degree Celsius could be saved by reducing the indoor temperature needed to maintain a good thermal comfort in the apartments.

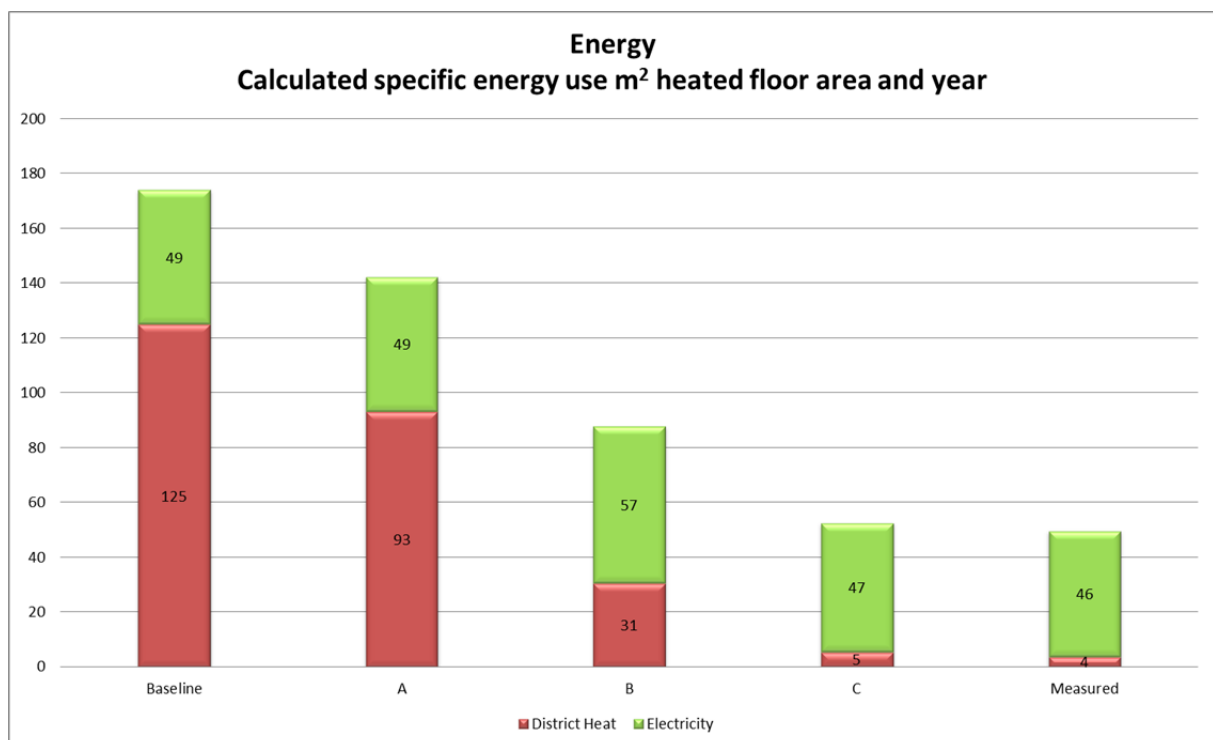
According to the measured energy use, the Halmstad project performed as calculated within the calculated economic frame. The measured energy use matched the calculated energy use very well, see Figure 15 and Figure 16, and the technology is operating as it should. See Work Package 5 for more information regarding the measured energy use.

Figure 15: The calculated specific energy use (purchased) for the actual building (baseline) compared to savings packages A, B, C and measured.
