# E2ReBuild

Industrial Energy Efficient  
Retrofitting of Resident  
Buildings in Cold Climates

## D2.3 Demonstrator Voiron

<b>Project no:</b>	260058	<b>Project acronym:</b>	E2ReBuild
<b>Due date:</b>	2014-06-30	<b>Submission date:</b>	2014-06-24
<b>Dissemination:</b>	Public		
<b>Partners:</b>	<u>OPAC38</u>		
<b>Authors:</b>	<u>Benoît JEHL</u>

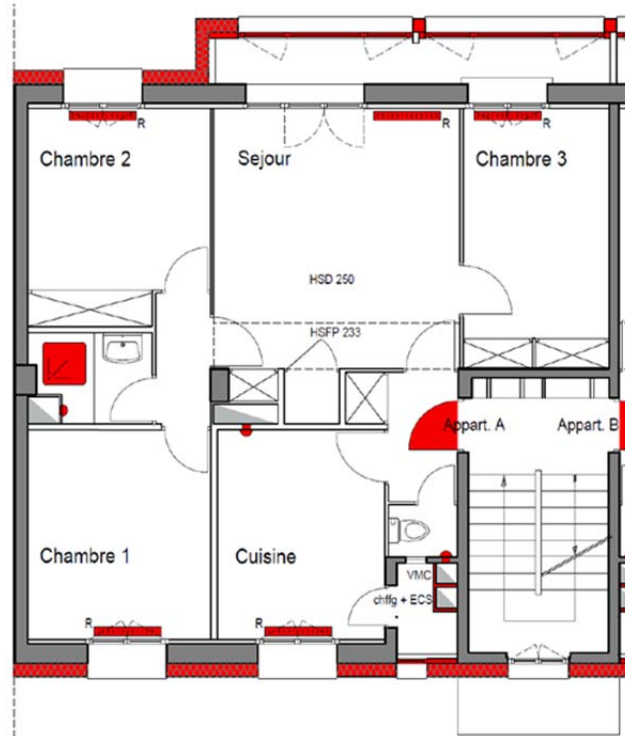
- Wall, roof and floor insulation;
- Closing of the balconies;
- Creation of a mechanical ventilation system;
- Creation of a collective gas heating system;
- Installation of solar thermal panels;
- Bathroom renewal (change of the former bath for showers);
- Change of the entrance doors;
- Renewal of the entrance hall with installation of an access phone;

- Renewal of the electrical system;
- Repair of the water disposal;
- Construction of an approach ramp to the hall already equipped with a lift (to eradicate the 3 existing stairs).

Figure 3: Layout of one dwelling with changes in red

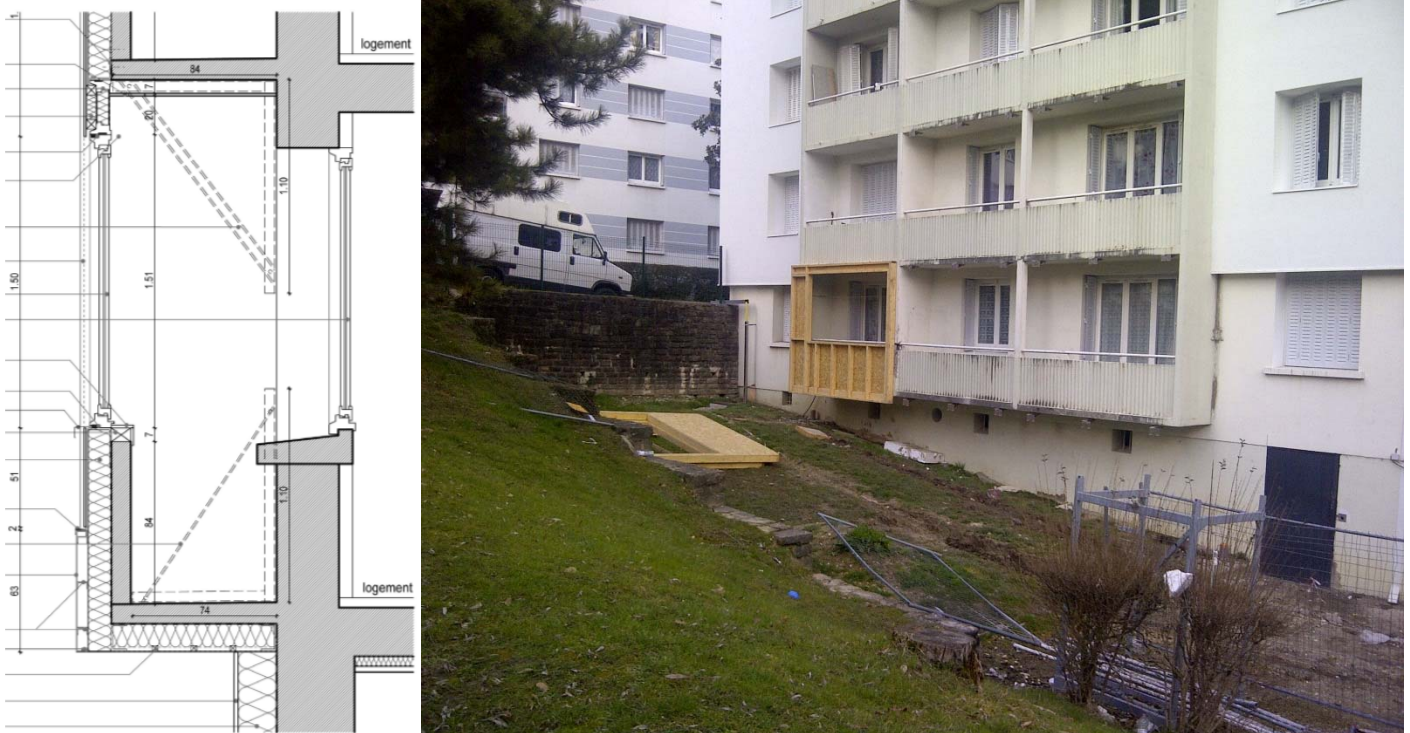
That's why OPAC38 had to reduce the use of prefabrication to some elements of the façade of the loggias [Figure 5]. Those elements were prefabricated at the plant, and then transported and erected on site:

- a PVC frame over the all length and breadth for each loggia was mounted on the window back (part between the sill and the floor) that contains several windows (fixed or that can be opened), as well as a full and insulating over panel (part over the windows)
- the rest of the façade of the loggias is insulated with OSB (Oriented Strand Board) sandwich boards with 120 mm polyurethane

Figure 5: Detail and picture of the prefabricated elements for the balconies

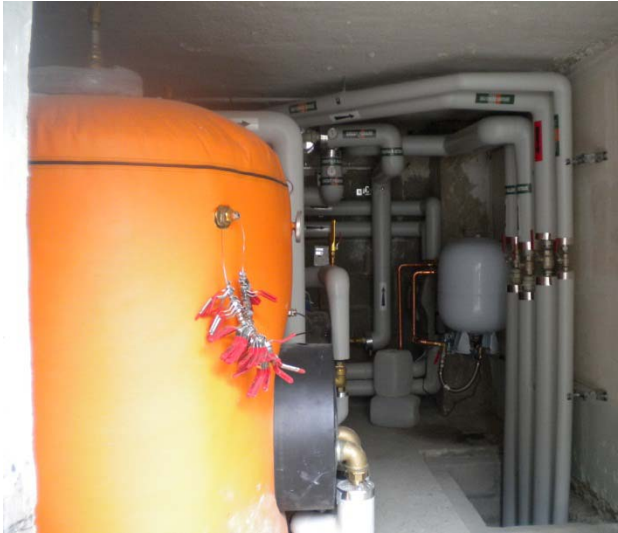
The existing individual gas boilers and electric heaters were replaced by a collective gas boiler (700 kW) [Figure 7] and solar thermal panels (91 m<sup>2</sup>) [Figure 8]. The boiler room is located in the basement (former cellars were used) and radiators have been installed in the dwellings. Solar panels are located at 4 different places on the roof: their expected production is 57 400 kWh/year, contributing to 51% of the needs.

Figure 7: Boiler room

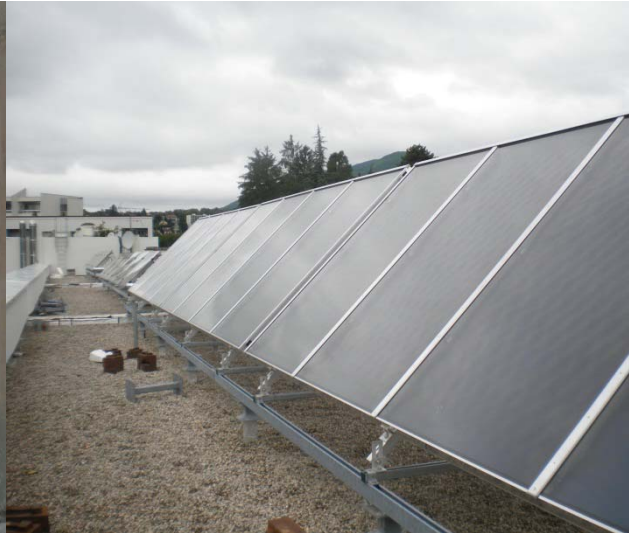
Figure 8: Solar panels

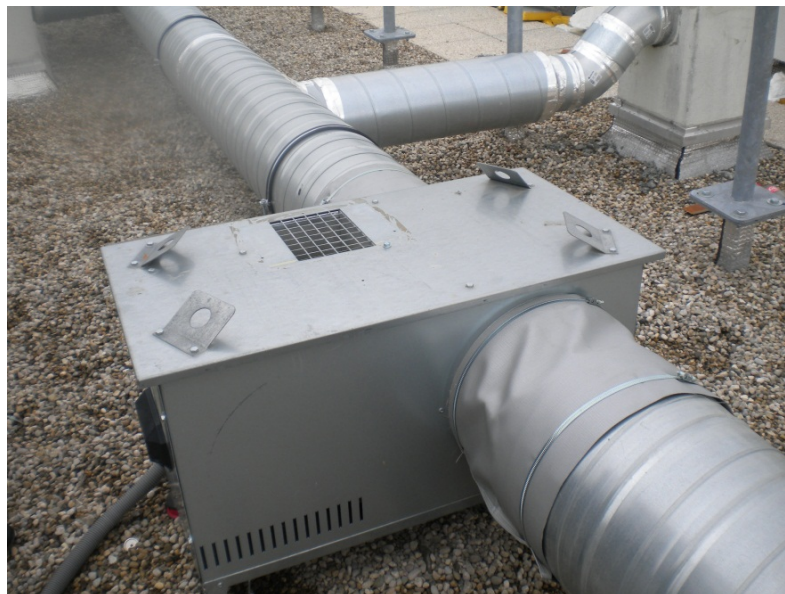
Mechanical ventilation with hydrothermal air inlet was created. Fans are located on the roof [Figure 9], and the former chimneys, after their airproofing, have been used for extracting air in the dwellings.

Figure 9: Ventilation fans and ducts

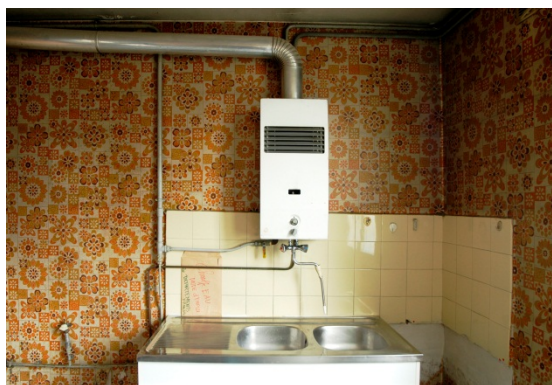
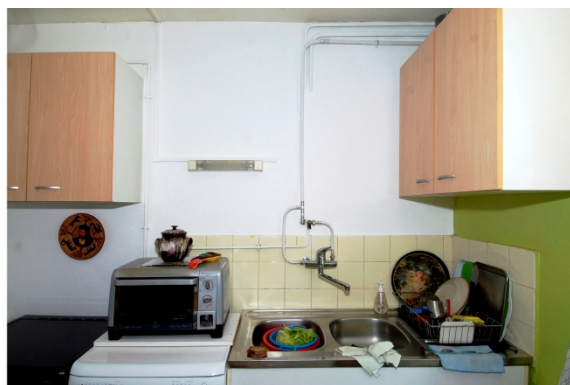
Figure 10: Kitchen renewal

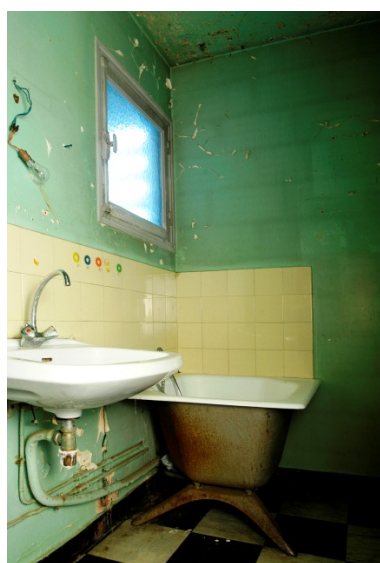
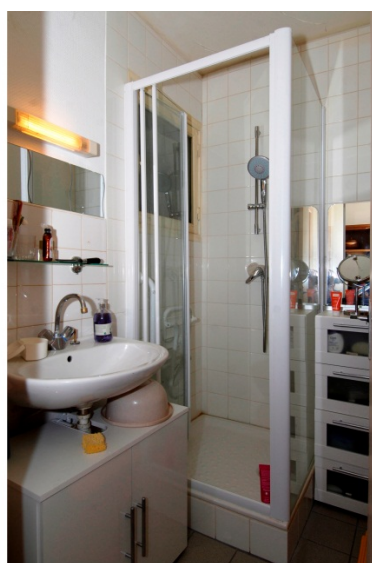
Part of the work program was not related to energy efficiency but rather to improve comfort. This was the case for the changes in the bathroom [Figure 10]: most of the tenants are rather old and had difficulties to use bath, this is why bathrooms were renewed. Side works in the kitchen [Figure 10] and rooms were also needed because of the heating system, and new equipment was installed [Figure 12]:

Figure 11 Bathroom renewal

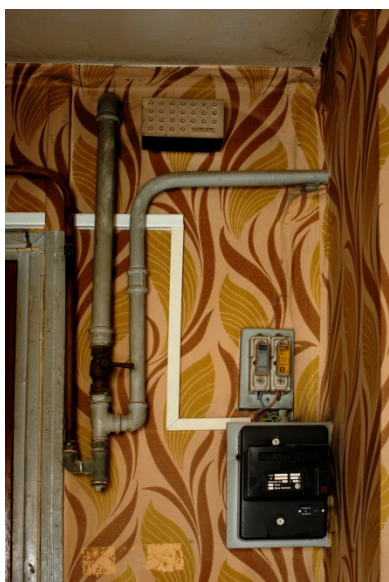
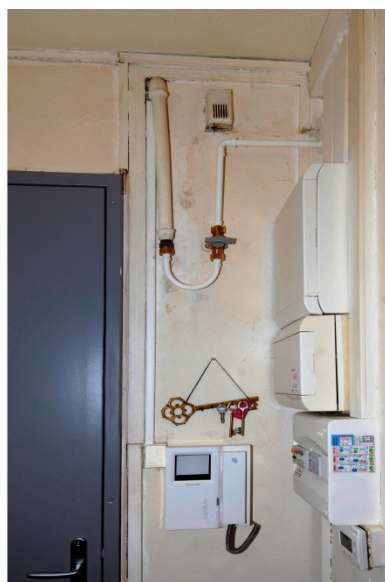
Figure 12: Changes in the entrance

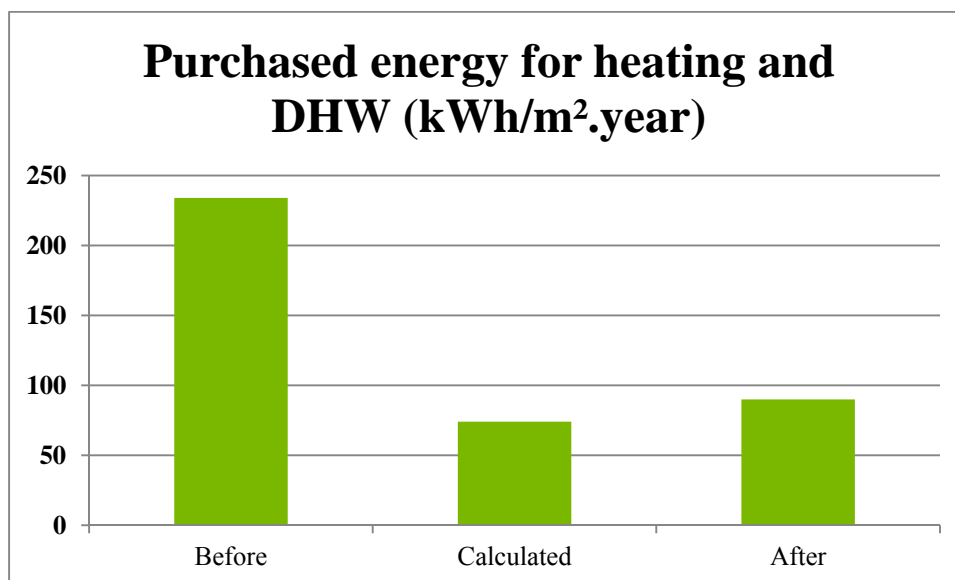
According to measured energy data, the project however still has possibilities for improvement [Figure 14]. Adjustments are still on going to improve the overall performance and reach the initial goals. Temperatures measured in the dwellings are still above 20°C, when calculation was based on 19°C. The reduced temperature over night was only recently applied. For DHW, temperature was once again

too high and was recently reduced by 5°C. This shows the importance of monitoring on reaching the initial goals.

Figure 14: Energy needs before, expected and after
